Victoria Mills, Grimsby

Using drones to protect one of North East Lincolnshire's most iconic buildings

Drone surveying Grimsby's iconic Victoria Mills makes it possible to identify potential issues in a fraction of the time and cost

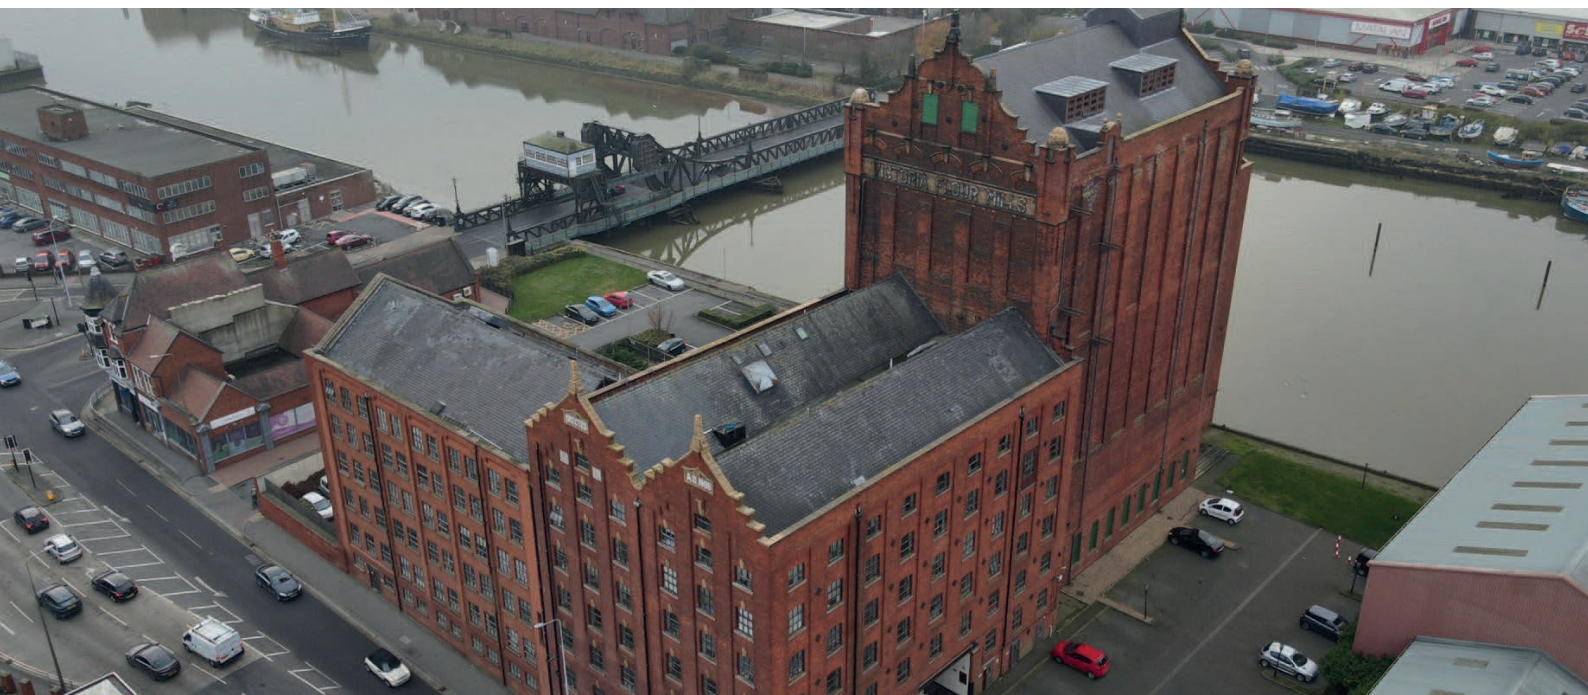
A brick and masonry survey was carried out at 4m building – drone span and assessed by surveyors. No obvious blemishes or brickwork issues were identified. Some foliage has started to settle in recessed brickwork which has been identified as needing further monitoring.

One slipped roof tile was identified revealing a small hole. This will need repairing at a future date. All rainwater goods are clear and working appropriately. No blockages or debris were visible. There was no evidence of birds or other wildlife, suggesting no risk of damage caused by nesting birds.

Thermal imaging shows no unexpected heat-loss for a building of this size and condition.
